TO: Public Works Committee
FROM: Joe C. Wilder, Director of Public Works *JCW*
SUBJECT: Meeting of January 25, 2022
DATE: January 19, 2022

RE: Revision 1 - Report of Geophysical Investigation
[Crystal Lake Sinkhole Investigation \(Cherokee Dam\)](#)
152 Tomahawk Trail, Winchester, VA
VEPC Project No: PTL-212862

SUBJECT: Cherokee Lake Sinkhole(s) Remediation Recommendation

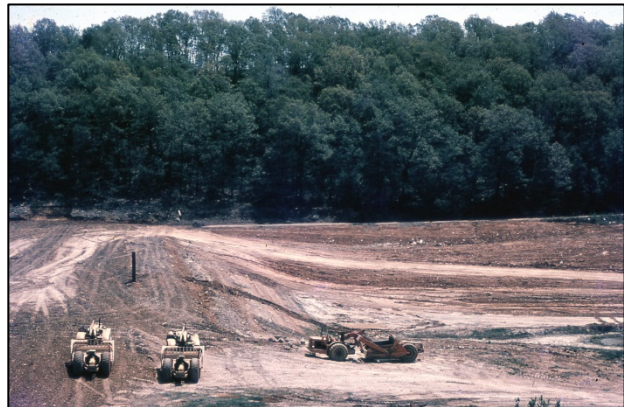
Figure 1. Dam Construction

Cherokee Dam is located perpendicular to the strike of bedrock underlain by various geological formations, several of which include soluble limestone. We understand the site and dam embankment is underlain by several geologic formations with limestone inclusions that are solution prone according to published maps, review of previous site study, and grouting program performed by Hayward Baker.

Based on a review of the grouting program, we summarize that grouting began in November 2008 and was terminated in April of 2009. A total of 33 borings were injected with grout to depths of 150 feet, as referenced from the top of the dam, with a cement grout/bentonite additive. Records indicate a total of 2097 cubic yards of grout was injected to develop a subsurface curtain that appeared to minimize water flow through subsurface voids at depth. However, it was stated some leakage is inevitable in this karst geology. We conclude that it is nearly impossible to effectively stop leakage in karst geology nor can any grouting plan guarantee similar future sinkhole development will not occur. However, targeted remediation can significantly reduce the likelihood of drainage through karst development and reduce subsurface drainage rates.

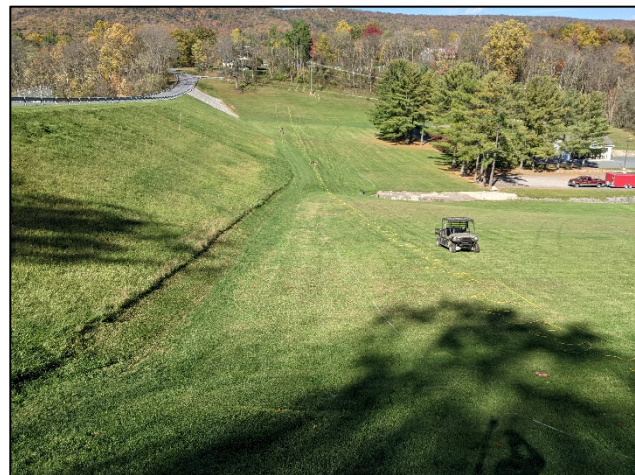
Figure 2. ERI Field Investigation

A three-dimensional ERI survey along [six \(6\) parallel lines](#) running east to west along the downstream slope and toe of Cherokee Dam. The study included a [dipole-dipole](#) array resistivity survey utilizing the Advanced Geosciences, Inc. (AGI) SuperSting R-8/IP Passive Earth Resistivity System. The ERI lines were spaced approximately 16 feet apart with a length of 664 feet each. The resistivity lines were established with an electrode spacing of 8 feet to gain a maximum resolution and imaging depth of approximately four (4) and 130 feet, respectively. Anomalous resistivity zones were mapped in an effort to identify flow paths which traverse the survey area to distinguish potential remediation areas. Further, resistivity imaging data was processed and inverted using AGI's proprietary 3-D resistivity inversion software, EarthImager 3-D, to generate the inverted resistivity sections. Terrain correction was performed utilizing high resolution elevation data obtained from USGS 3DEP one-meter Light Detection and Ranging (LiDAR) bare earth elevation maps. Electrodes were located in the field with multi-band RTK GNSS receivers with a nominal location accuracy of less than three (3) centimeters.

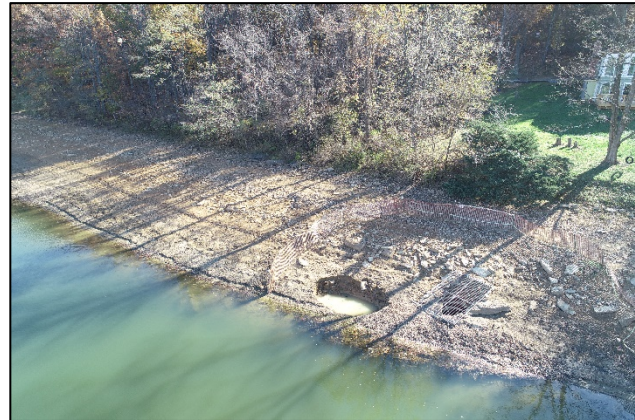
Figure 3. Sinkhole Development Along Shoreline

Resistivity imaging of the project site suggests variable moisture conditions beneath estimated top of bedrock likely indicated zones of water infiltration. Zones of higher resistive material likely represent competent bedrock while lower resistivity values were observed along the existing dam outfall barrel and buried piping (siphons). A discontinuous low resistivity zone is noted on all ERI sections along the eastern edge of the ERI data. This area is indicative of fractured bedrock harboring water flow. Further, it is believed the contact between dissimilar geologic formations is closer to the site than is mapped leading to accelerated bedrock degradation. A zone of probable remediation was identified along the eastern extents of the survey area as mapped on the attached Location Plan and Inverted Resistivity Sections. An area of low resistivity subsurface conditions was noted due west of the dam outfall pipe only in a handful of sections. It is believed this hydraulic feature is derived from water infiltration at the surface near the end of the outfall pipe.

Based on the 2009 remediation history and existing subsurface flow that developed after a period of 13 years, we recommend injecting a polyurethane resin at this time to minimize subsurface flows as mentioned. This approach incorporates additional deep remediation at a fraction of the cost of conventional pressure grouting. The resin can be properly mixed with an accelerant to cause a solid plug to set at a precise time to effectively fill the karst void(s) along the drainage path. Further, our review of products and procedures indicates that the resin can be pumped into the existing sinkhole, which avoids drilling injection borings along the dam embankment thereby reducing cost and time for completion. We suggest that a preferred Contractor be contacted to evaluate the site to determine a budget cost to restore the lakes level to near normal utilizing a polyurethane resin. Based on a quote for 500 gallons of bulk material, we estimate a cost to remediate Crystal Lake ranging between \$60,000 and \$380,000 depending on the severity of voids in the underlying karst geology. Upon completion, we recommend that the exposed throat of the sinkhole(s) be backfilled with a lean concrete (2000 psi concrete) amended with high yield bentonite gel (powder) at a typical rate of 50 pounds/cubic yard of concrete. This will provide a tight sealing plug that will promote public safety. Further site remediation work may be required in the future, as this approach will plug the current karst drainage path. Active maintenance, incorporating this or comparable techniques, may likely result in a lower total site remediation cost if future subsurface leaks develop. We recommend that Mr. Stuart Baber be invited to speak of this process at the next Homeowners Board Meeting based on his expertise and to answer questions accordingly.
